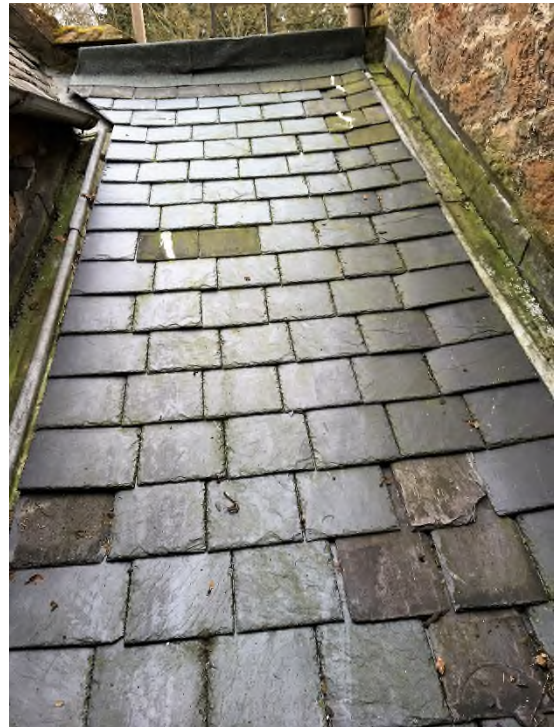
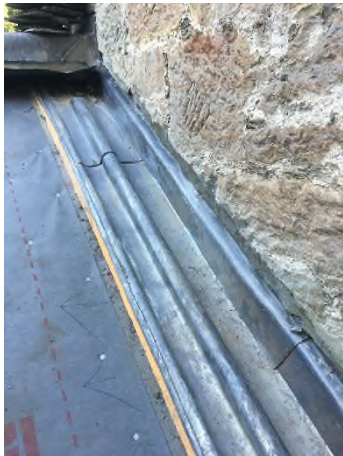
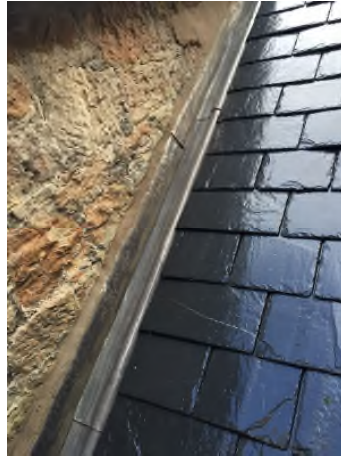
The Section of roof on this building had been poorly slated and the work carried out with inferior materials, poor quality slates and finishing's. The slates used were not of sufficient length or width to provide suitable water proofing to the roof.

The mismatched slates resulted in water ingress during heavy rain.
